**JEROME PARK RESERVOIR DAM  
BRONX COUNTY, NEW YORK**

**NY 64  
PHASE I INSPECTION REPORT  
NATIONAL DAM SAFETY PROGRAM**

Prepared by  
CONVERSE WARD DAVIS DIXON  
CONSULTING ENGINEERS  
91 ROSELAND AVENUE, P.O. BOX 91  
CALDWELL, NEW JERSEY 07006

10. CONTROLLING OFFICE NAME AND ADDRESS New York State Department of Environmental Conservation 50 Wolf Road Albany, New York 12233		11. REPORT DATE 5 September 1978		12. NUMBER OF PAGES 12

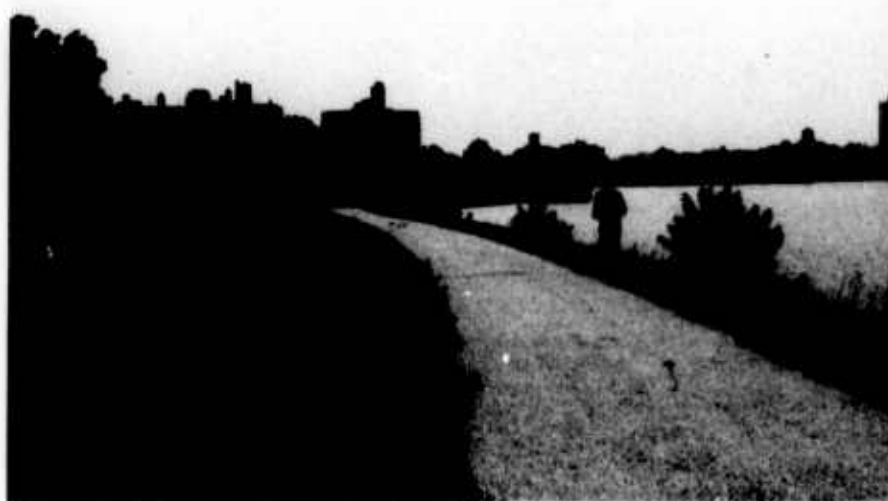
FIGURE 2 WESTERN EMBANKMENT AND SEDGEWICK AVENUE  
LOOKING NORTH

In general, all earthen embankments were found to be grass covered and very well maintained (Figs. 2 and 3, Appendix D). No seepage was detected on or at the toe of the downstream slopes. A chain link fence, with barbed wire top in some areas, encircles the reservoir (Fig. 3, Appendix D). Along the western and northern portions of the perimeter, the fence is at or near the toe or toe wall of the embankment. There is a paved city street usually within 50 feet of the fence in these areas, and beyond that private residences. Consequently, no evidence of seepage beyond the toe could be observed.

A small section of the chain link fence surrounding the reservoir was missing along the eastern perimeter on the day of the inspection. We were informed by NYCDWRBWS personnel that breaches such as this were commonplace and that the one observed had not been there the previous day. It became apparent during the inspection and from conversations with Messrs Ragucci and Kuse that security measures in effect at the reservoir were not totally effective. We were informed that four trespassers had drowned in the reservoir in the past two years. On the day of the inspection, joggers (trespassers) were observed within the compound (Figs. 2 and 3, Appendix D).

(e) Breaches of the chain link fence should be repaired.
